6th International Conference on Creep, Fatigue and Creep-Fatigue Interaction [CF-6]

Fatigue Failure of a Distortion Screen during Testing

Materials Group, Gas Turbine Research Establishment, Bangalore 560093, India

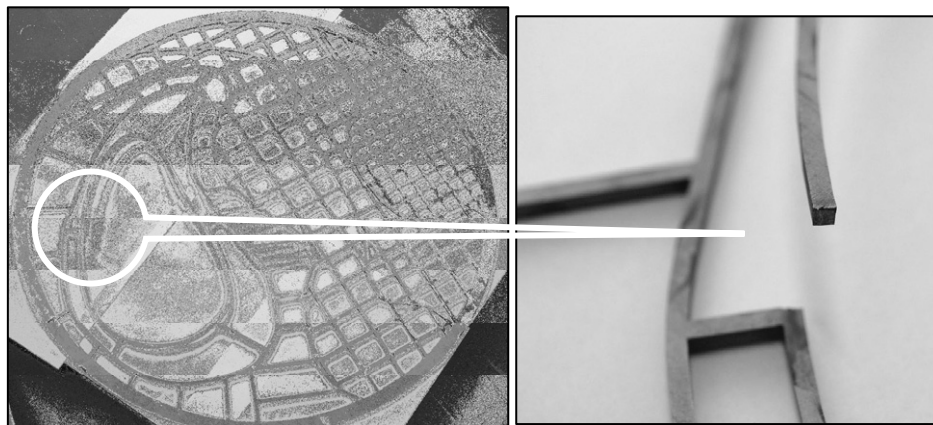
The distortion screen got permanent deformation in the flow direction in the region where the grid size was maximum. It was found to have fractured from a rib joining two meshes (Fig. 2). Loose end of the mesh had come out & resulted in permanent deformation to the adjoining ribs & meshes. The fractured surface of the loose end revealed glossy crystalline appearance (Fig. 3). Traces of pink tints were noticed on the fractured surface indicating dye penetrant inspection (DPI) after failure.

Fig. 2. Photograph of the failed distortion screen.

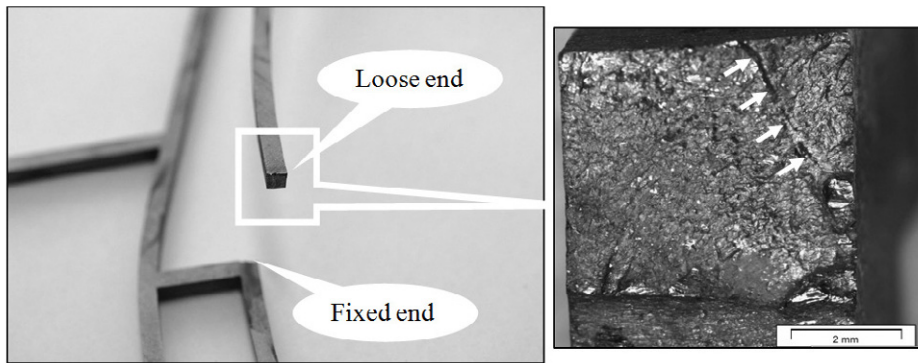
The fractured portions were cut from the screen at suitable locations to study the mode of failure. The fractured surface of the loose end (refer Fig. 3) revealed post fracture damage (rubbing) on almost the entire surface. The fractured surface of the fixed end was less damaged comparatively. A step was noticed on the fractured surface indicating simultaneous propagation of two crack fronts (Fig. 3).

Fig. 3. Crystalline appearance of the fractured surface; arrows indicating step observed on fractured surface.

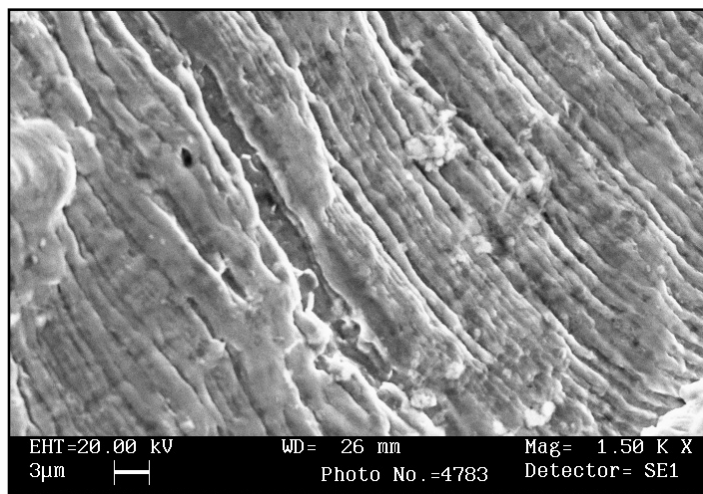
Both the samples were cleaned using ultrasonic cleaner and studied using Scanning Electron Microscope (SEM). The fractured surface of the fixed end revealed striations at higher magnifications ($>500\times$) as was observed (Fig. 4) in case of fatigue failure [5]. Striations were noticed on almost entire fractured surface.

Fig. 4. Fatigue striations on the fractured surface of fixed end.

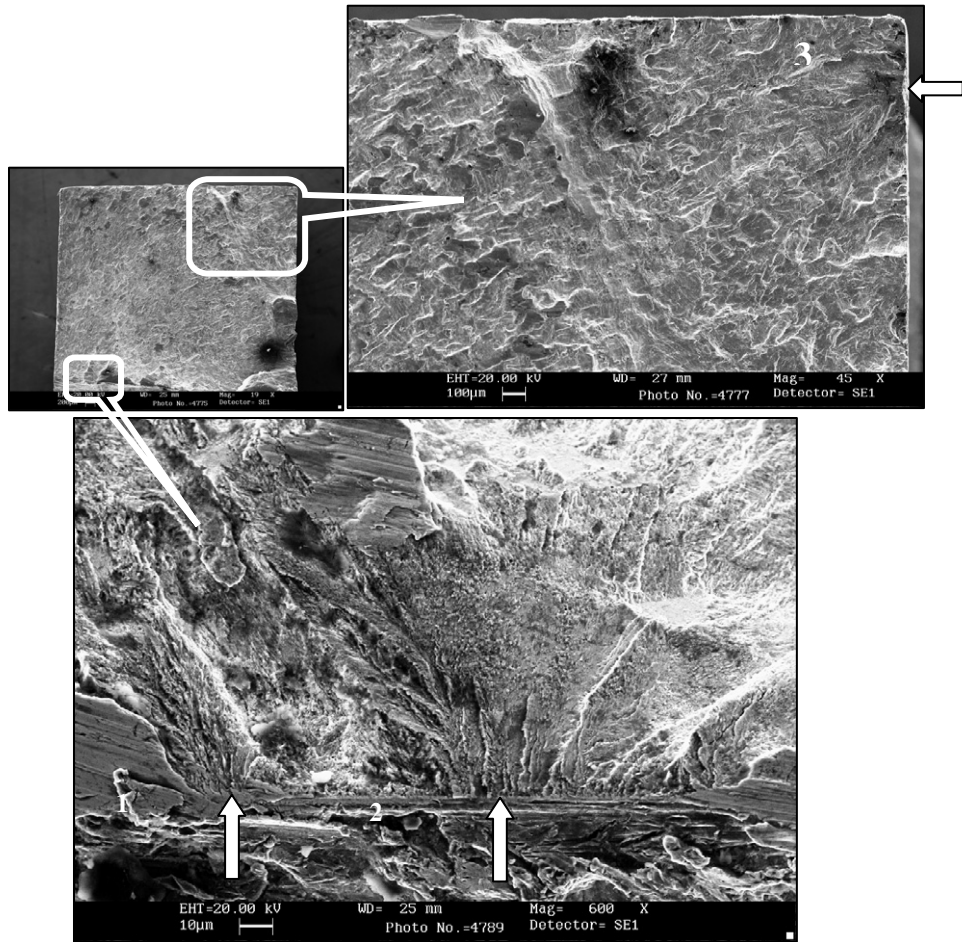
Tracing back the orientation of the crack fronts, three crack origins were found on the surface (Fig. 5). Two crack fronts were adjacent and near to one corner of the rib, and the other crack front had originated from the other corner placed diagonally opposite to the two crack fronts (refer Fig. 5).

However, all the edges of the fractured surface were damaged by post fracture rubbing and so details at the crack origins could not be studied. It may be noted here that a depression was noticed at the crack origin 3 (refer Fig. 5).

Fig. 5. Fractured surfaces at higher magnification; arrows point to the crack origins.

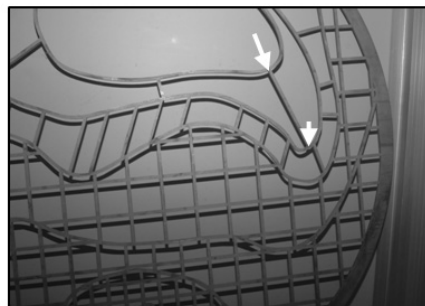
Fig. 6 Arrows showing location of cracks in the distortion screen after testing.

Two more cracks were noticed on the distortion screen at the ends of rib joining the fractured rib and other mesh (Fig. 6). One crack was on the front face of the screen and the other one was on the rear side. This may be attributed to the differential flexure of screen due to the complex geometry of the mesh.

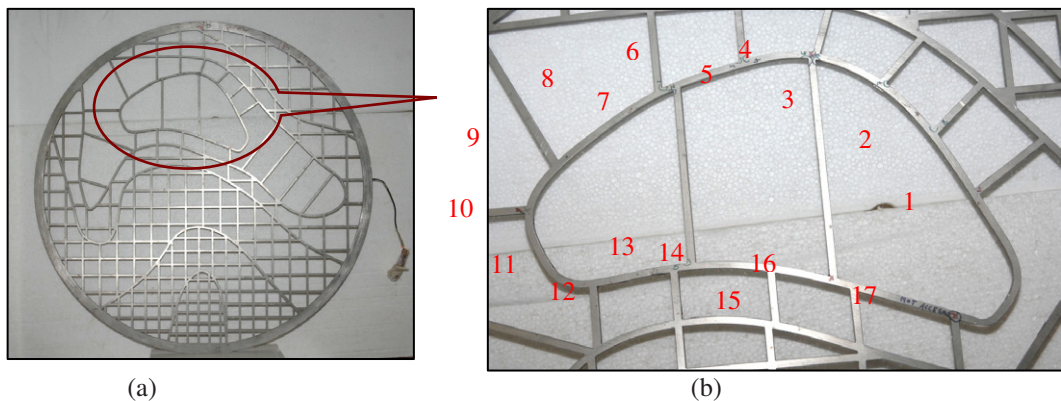
Fig. 8 a) Modified Distortion screen b) photograph showing critical portions in the screen.

After the test was completed visually no deformation was found on the screen (as found on previously designed distortion screen). The rib joints in the critical portions (previously where failures were noticed in the distortion screens) marked 1 to 17 (Fig. 8 (a) & (b)) were closely observed under stereomicroscope. None of these joints revealed any crack.

Change of material and design modifications with adequate structural support were suggested. Subsequent to this analysis a new distortion screen was designed and tested. The design of this distortion screen was more stiff as compared to the previous distortion screen, as it is supported by additional rib joints in the critical portions. Figure 7 shows the changed design at the failure location of previous and corresponding location in the modified distortion screen.
